**Flood Control Project Maintenance  
Levee Inspections****LMA District Cover Sheet****Spring 2013 Levee Inspection Results****Reclamation District No. 0404 Boggs**

**Levee Inspection Report By Mile - Spring 2013**

**Reclamation District No. 0404 Boggs**

Waterway				Bank	Unit Miles	Inspection Start/End	Inspector	
Unit No. 01 San Joaquin River				Right	2.36	04/10/2013 04/10/2013	Richard Willoughby

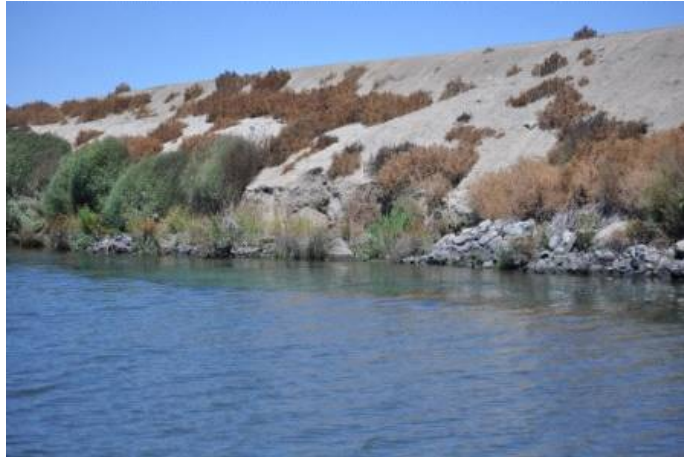
Levee Mile Report Line	6
Start Levee Mile	0.21
End Levee Mile	0.26
Location	Water Side
Category	Supplemental
Item	DWR Erosion Survey

Downstream view of Site. Progressing pocket erosion visible.

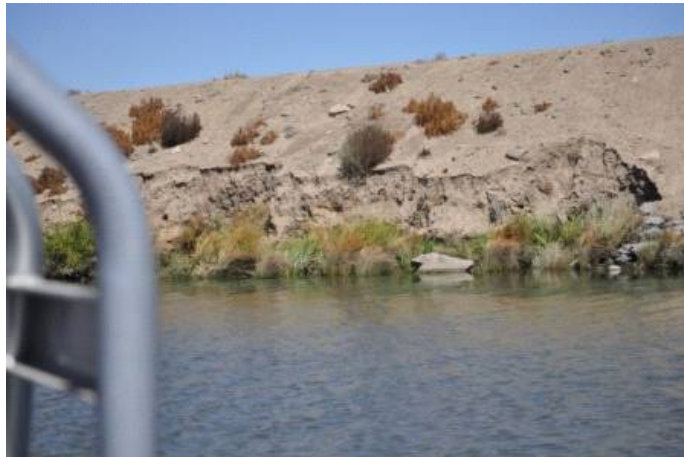
Front view of the site

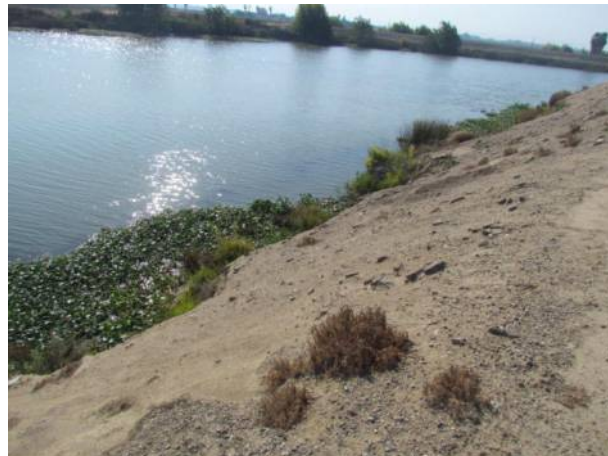
Levee Mile Report Line	7
Start Levee Mile	0.30
End Levee Mile	0.30
Location	Water Side
Category	
Item	Erosion / Bank Caving

DWR ID: DWR_RD0404_01_s_2013_1									
7	0.30	0.30		Erosion / Bank Caving	WS M Ma	E1 : Note and monitor erosion site. Inspector Comments: Erosion appears to increase in size.	37.939420 ° -121.341643 °	37.939420 ° -121.341643 °	105 Y
DWR ID: DWR_RD0404_01_s_2012_105									
8	0.44	0.44		Animal Control	CR M Ma	A3 : No rodents visible, but rodent burrows visible; need to backfill and compact or grout burrows. Inspector Comments: One large rodent located on levee crown and several rodent holes also located in this area.	37.939635 ° -121.339063 °	37.939635 ° -121.339063 °	5 Y
DWR ID: DWR_RD0404_01_s_2013_5

Looking northwest at toe erosion on waterside.

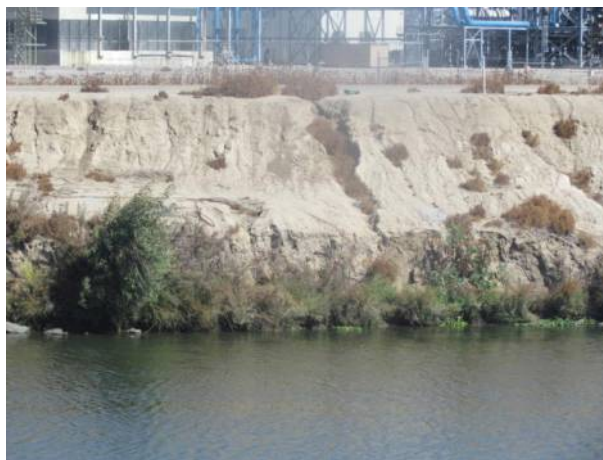
Levee Mile Report Line	7
Start Levee Mile	0.30
End Levee Mile	0.30
Location	Water Side
Category	
Item	Erosion / Bank Caving

Looking east at erosion on slope and toe of levee.

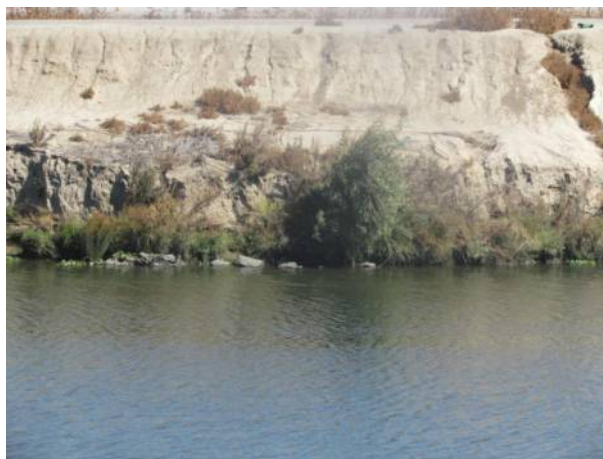
Levee Mile Report Line	7
Start Levee Mile	0.30
End Levee Mile	0.30
Location	Water Side
Category	
Item	Erosion / Bank Caving

Looking east from RD 524 at erosion on slope and toe of levee.

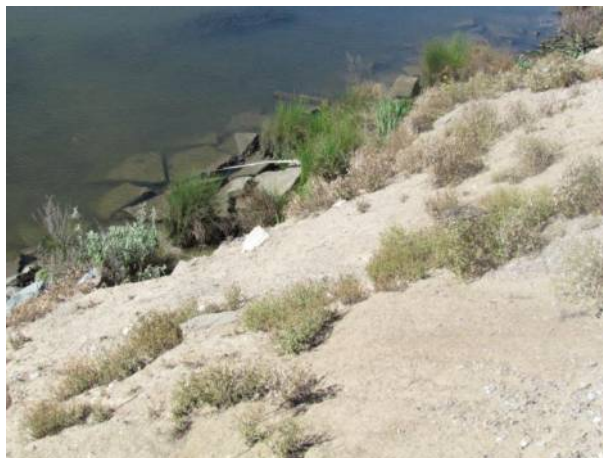
Levee Mile Report Line	7
Start Levee Mile	0.30
End Levee Mile	0.30
Location	Water Side
Category	
Item	Erosion / Bank Caving

Looking west at erosion on waterward toe.

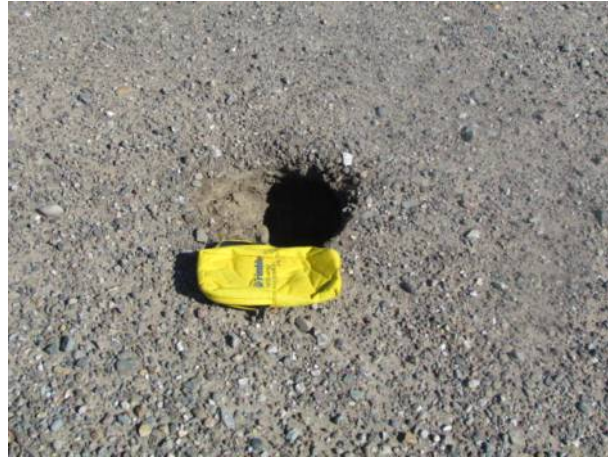
Looking at rodent hole on levee crown.

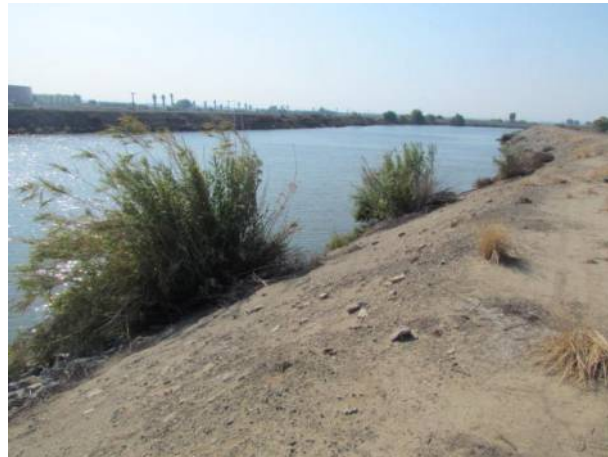
Levee Mile Report Line	9
Start Levee Mile	0.45
End Levee Mile	0.45
Location	Water Side
Category	
Item	Vegetation

LMR No.	Levee Mile		Category	Item	Location * + Rating	Action/Comment	GPS Latitude/Longitude		Issue No.
	Start	End					Start	End	Photo
9	0.45	0.45		Vegetation	WS Ma	V2 : Remove the wild growth other than native grasses from the levee slopes. Inspector Comments: Remove bamboo on waterside toe. Bamboo is not within twenty feet zone, but should be removed to stop from spreading along waterward slope.	37.939627 ° -121.338808 °	37.939627 ° -121.338808 °	104 Y
DWR ID: DWR_RD0404_01_s_2012_104									
10	0.48	0.48	Supplemental	DWR Erosion Survey	WS Ma	Inspector Comments: 8/7/2012: The erosion is next to a repaired site and approximately 400 feet downstream of a river bend. There are broken concretes at the upper levee slope, but not visible at the levee toe or lower slope. Likely the protection concrete blocks have been washed away [2012 Site ID:RD0404U01RM41.11]	37.939190 ° -121.338280 °	37.939190 ° -121.338280 °	18 Y

Looking northwest at bamboo on waterside toe.

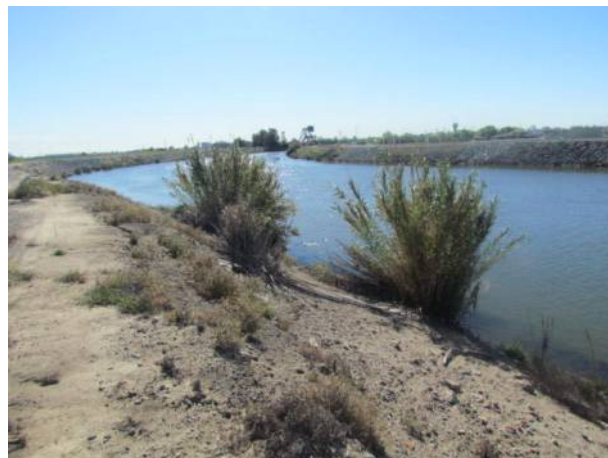
Levee Mile Report Line	9
Start Levee Mile	0.45
End Levee Mile	0.45
Location	Water Side
Category	
Item	Vegetation

Looking southwest at bamboo on waterward slope and toe.

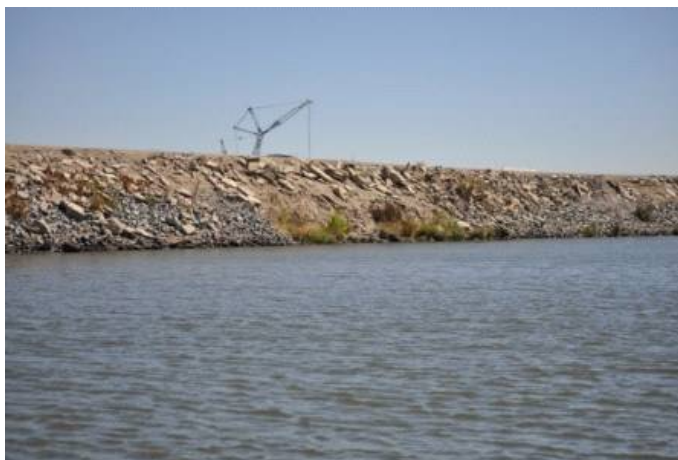
Downstream view of the site.

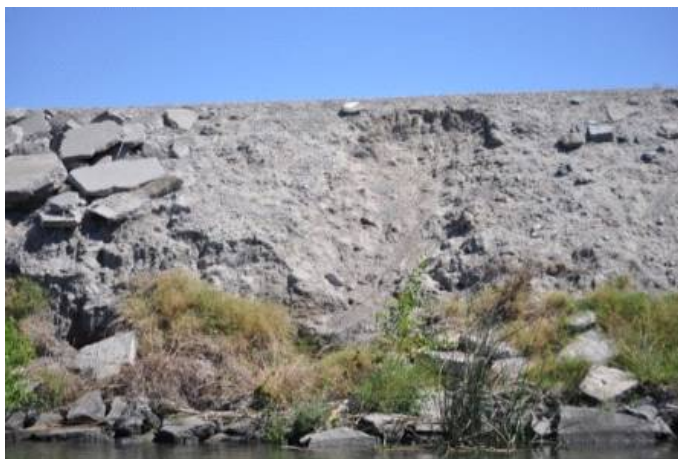
Levee Mile Report Line	11
Start Levee Mile	0.60
End Levee Mile	0.62
Location	Water Side
Category	Supplemental
Item	DWR Erosion Survey

DWR ID: DWR_RD0404_01_s_2013_18									
11	0.60	0.62	Supplemental	DWR Erosion Survey	WS Ma	Inspector Comments: 08/07/2012: The site was first discovered by levee inspector in the spring inspection. Levee slope was protected with broken concrete blocks, but those blocks have been washed away during high flows. [2012 Site ID:RD0404U01RM41.22]	37.939133 ° -121.336100 °	37.939133 ° -121.336100 °	19 Y
DWR ID: DWR_RD0404_01_s_2013_19									
12	0.62	0.62	Supplemental	DWR Erosion Survey	WS Ma	Inspector Comments: 08/07/2012: The rootball of a fallen tree removed material from the levee. Immediately action needed to remove the fallen tree trunk and repair the damage. [2012 Site ID:RD0404U01RM41.23]	37.938810 ° -121.336170 °	37.938810 ° -121.336170 °	20 Y
DWR ID: DWR_RD0404_01_s_2013_20									
13	0.67	0.67		Encroachments	LS Ma	GA : Garbage Inspector Comments: Wooden board dumped on landside slope.	37.938583 ° -121.335258 °	37.938583 ° -121.335258 °	6 Y

Front view of the erosion. Note the slumping erosion at upper slope.

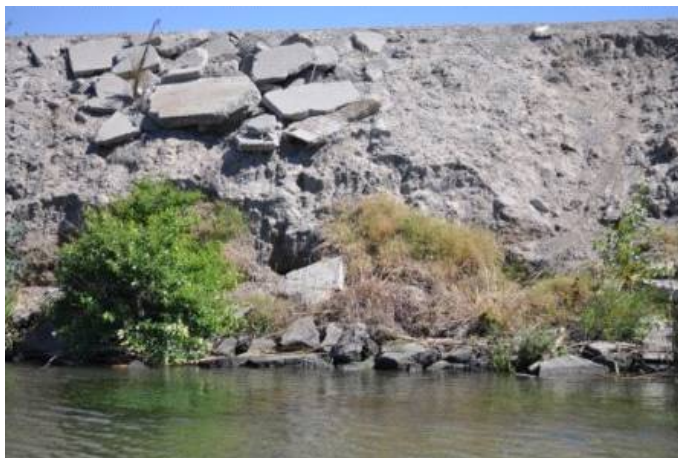
Levee Mile Report Line	11
Start Levee Mile	0.60
End Levee Mile	0.62
Location	Water Side
Category	Supplemental
Item	DWR Erosion Survey

Close view of erosion

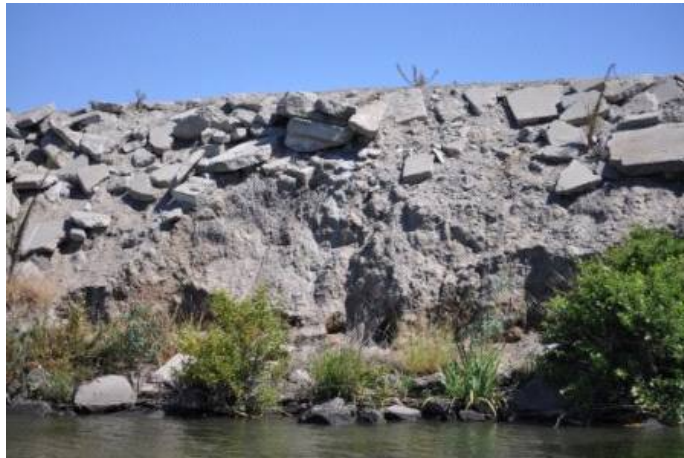
Front view of erosion. Note the broken concrete blocks at the slope.

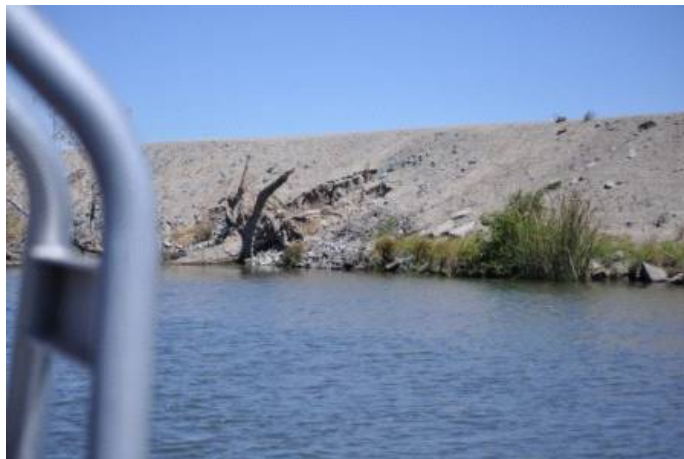
Levee Mile Report Line	12
Start Levee Mile	0.62
End Levee Mile	0.62
Location	Water Side
Category	Supplemental
Item	DWR Erosion Survey

Upstream view of the site

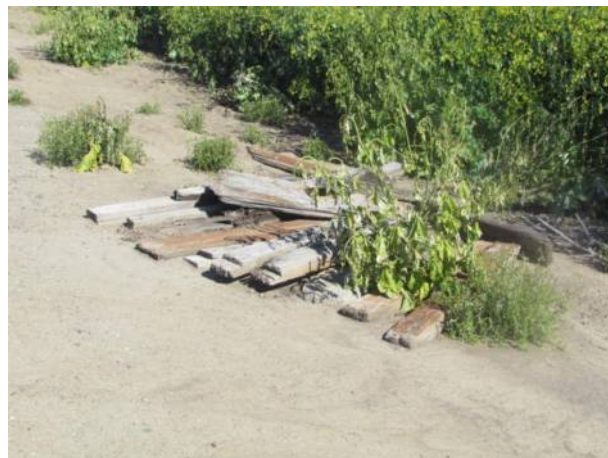
Levee Mile Report Line	13
Start Levee Mile	0.67
End Levee Mile	0.67
Location	Land Side
Category	
Item	Encroachments

Looking northeast at wooden boards on landward slope.

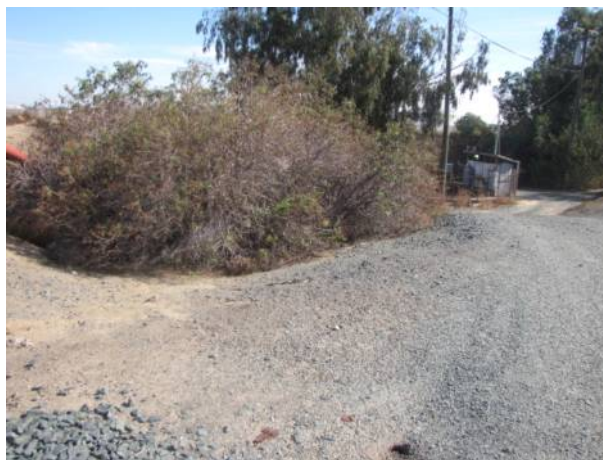
Looking southeast at elderberry on landside slope.

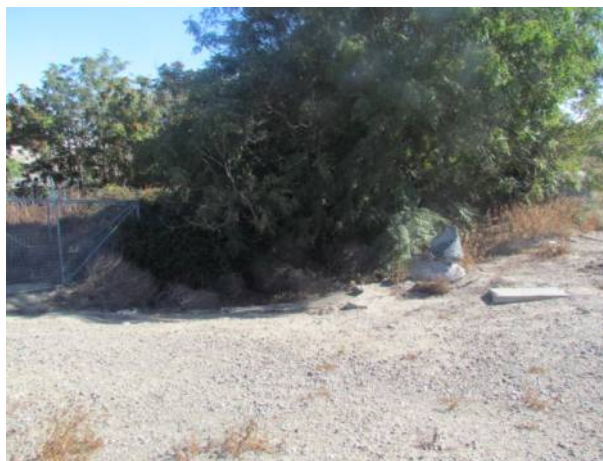
Levee Mile Report Line	19
Start Levee Mile	1.20
End Levee Mile	1.20
Location	Land Side
Category	
Item	Vegetation

DWR ID: DWR_RD0404_01_s_2012_102									
19	1.20	1.20		Vegetation	LS Ma	V2 : Remove the wild growth other than native grasses from the levee slopes.	37.934058 ° -121.328188 °	37.934058 ° -121.328188 °	101 Y
DWR ID: DWR_RD0404_01_s_2012_101

Looking southeast at overhanging trees on landside slope.

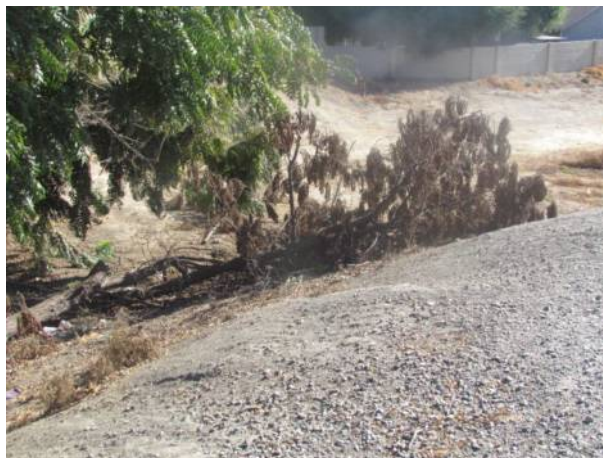
Levee Mile Report Line	23
Start Levee Mile	1.58
End Levee Mile	1.58
Location	Land Side
Category	
Item	Encroachments

Looking east at tree limb on landside slope.

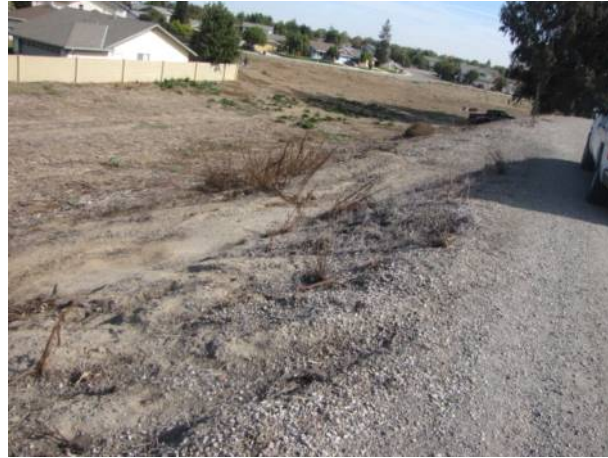
Levee Mile Report Line	25
Start Levee Mile	1.64
End Levee Mile	1.65
Location	Land Side
Category	
Item	Slope Stability
Looking northeast at minor slope damage on landside slope cause by vehicle traffic.	
richard_s_20130304_287.jpg

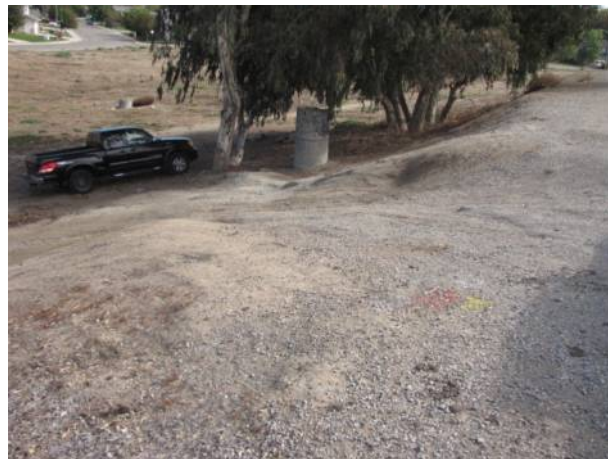
Levee Mile Report Line	25
Start Levee Mile	1.64
End Levee Mile	1.65
Location	Land Side
Category	
Item	Slope Stability
Looking northeast at slope damage on landside slope cause by vehicle traffic.	
richard_s_20130304_288.jpg

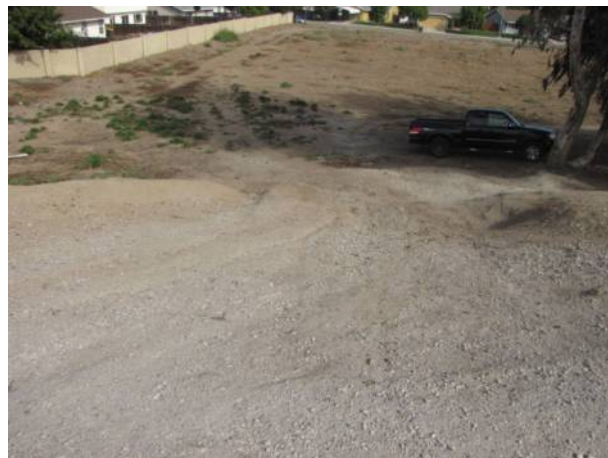
Levee Mile Report Line	25
Start Levee Mile	1.64
End Levee Mile	1.65
Location	Land Side
Category	
Item	Slope Stability
Looking east at slope damage on landside slope.	
richard_s_20130304_289.jpg

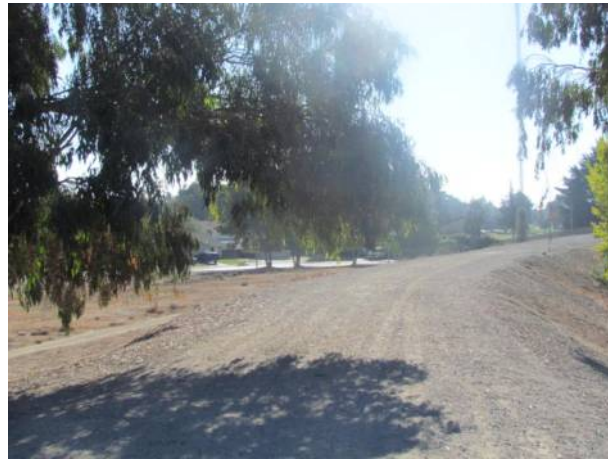
Looking east at tree on landside overhanging levee crown.

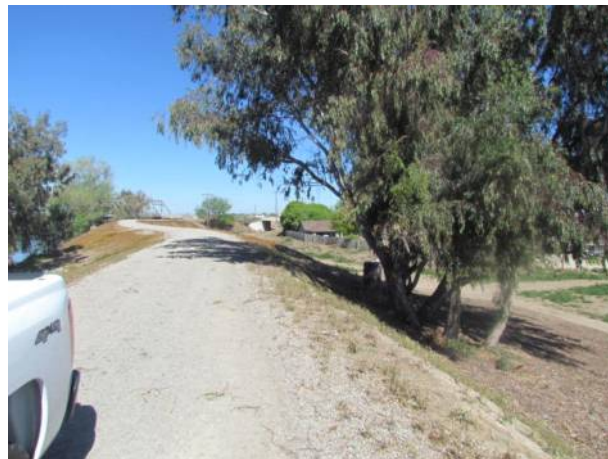
Levee Mile Report Line	26
Start Levee Mile	1.67
End Levee Mile	1.67
Location	Land Side
Category	
Item	Trim / Thin Trees

Looking north at trimmed tree on landward slope.(Spring 2013)

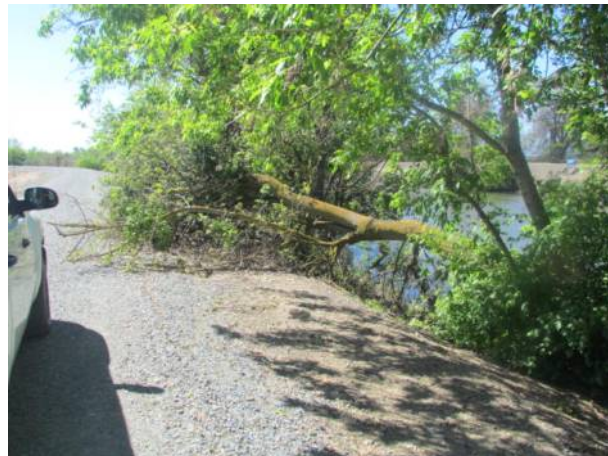
Levee Mile Report Line	29
Start Levee Mile	1.98
End Levee Mile	1.98
Location	Water Side
Category	
Item	Encroachments

DWR ID: DWR_RD0404_01_s_2013_21		
29	1.98	1.98		Encroachments	WS U En	TR : Tree or limb Inspector Comments: Downed tree limb on waterward slope.	37.924082 ° -121.323178 °	37.924082 ° -121.323178 °	22 Y
							DWR ID: DWR_RD0404_01_s_2013_22		
30	1.98	1.98		Trim / Thin Trees	WS M Ma	T1 : Trim trees to at least five feet above ground level.	37.924055 ° -121.323195 °	37.924055 ° -121.323195 °	99 Y
							DWR ID: DWR_RD0404_01_s_2012_99		
31	1.99	1.99		Encroachments	WS M Ma	TR : Tree or limb Inspector Comments: Downed tree limbs on waterside slope.	37.923817 ° -121.323130 °	37.923817 ° -121.323130 °	98 Y
							DWR ID: DWR_RD0404_01_s_2012_98		
32	2.08	2.08		Trim / Thin Trees	WS M Ma	T1 : Trim trees to at least five feet above ground level.	° °	° °	13
							DWR ID: DWR_RD0404_01_f_2012_13		
33	2.33	2.33		Trim / Thin Trees	WS C Ma	T5 : Tree stumps. Inspector Comments: Remove dead tree on waterside toe.	37.920585 ° -121.318850 °	37.920585 ° -121.318850 °	97

Looking south at broken tree branch on waterward shoulder and slope.

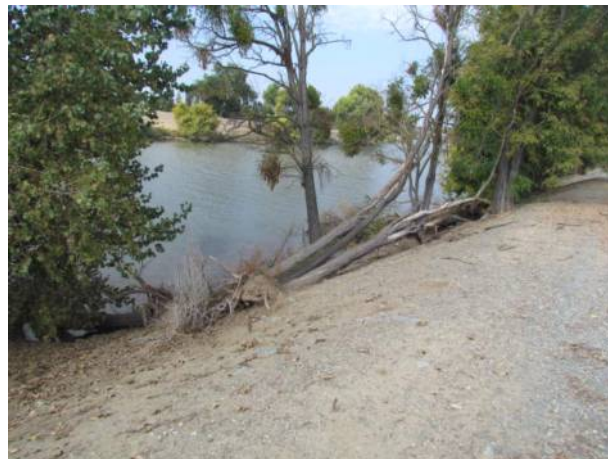
Levee Mile Report Line	31
Start Levee Mile	1.99
End Levee Mile	1.99
Location	Water Side
Category	
Item	Encroachments

Looking northwest at downed tree on waterside slope.

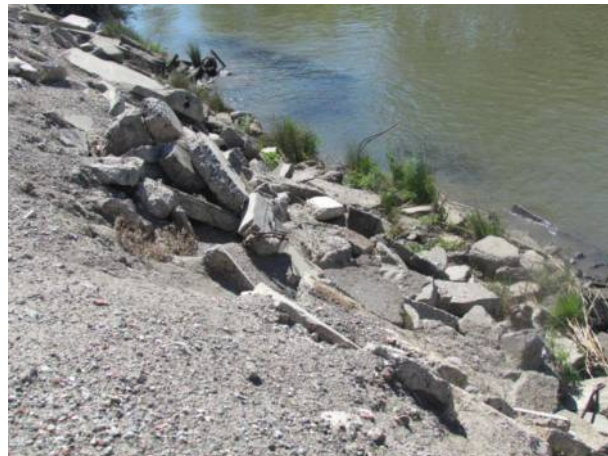
Levee Mile Report Line	34
Start Levee Mile	2.34
End Levee Mile	2.34
Location	Water Side
Category	
Item	Riprap Revetments

LMR No.	Levee Mile		Category	Item	Location *	Rating ** +	Action/Comment	GPS Latitude/Longitude		Issue No.
	Start	End						Start	End	Photo
34	2.34	2.34		Riprap Revetments	WS	M	Inspector Comments: Remove rebar from existing concrete rip rap on waterward slope.	37.920488 ° -121.318630 °	37.920488 ° -121.318630 °	23 Y
DWR ID: DWR_RD0404_01_s_ 2013_23

Looking southwest at concrete rip rap with rebar.

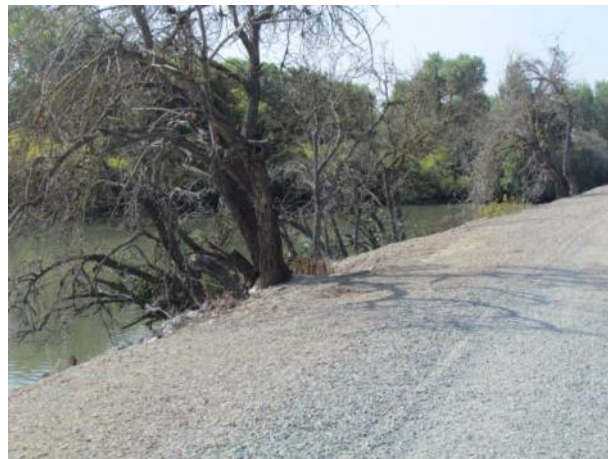
Levee Mile Report Line	5
Start Levee Mile	0.12
End Levee Mile	0.15
Location	Water Side
Category	
Item	Trim / Thin Trees

Looking northwest at dead trees on waterside slope.

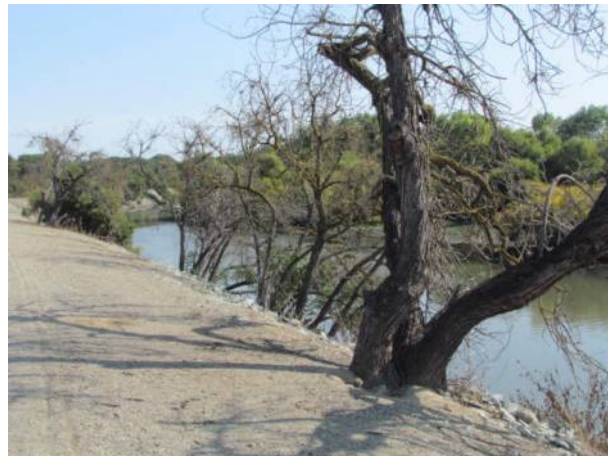
Levee Mile Report Line	5
Start Levee Mile	0.12
End Levee Mile	0.15
Location	Water Side
Category	
Item	Trim / Thin Trees

Looking southwest at dead trees on waterside slope.

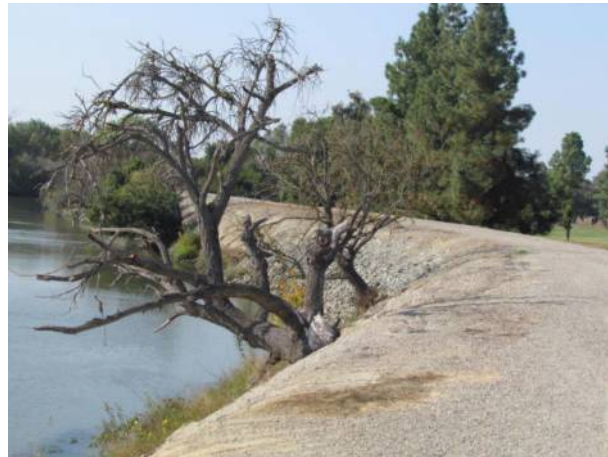
Levee Mile Report Line	10
Start Levee Mile	0.36
End Levee Mile	0.36
Location	Water Side
Category	
Item	Trim / Thin Trees

Looking northwest at dead tree on waterside slope.

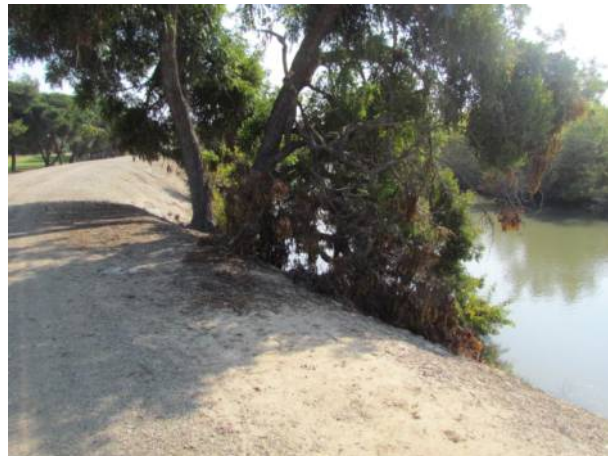
Levee Mile Report Line	13
Start Levee Mile	0.48
End Levee Mile	0.48
Location	Water Side
Category	
Item	Encroachments

Looking southeast at downed tree limb on waterside slope.

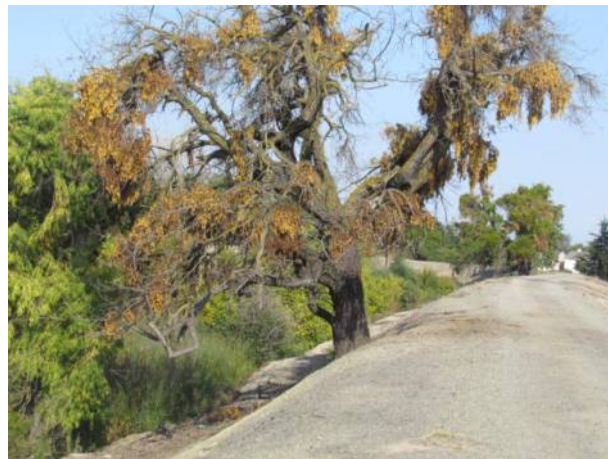
Levee Mile Report Line	19
Start Levee Mile	0.89
End Levee Mile	0.89
Location	Water Side
Category	
Item	Trim / Thin Trees

Looking northwest at dead tree on waterside slope.

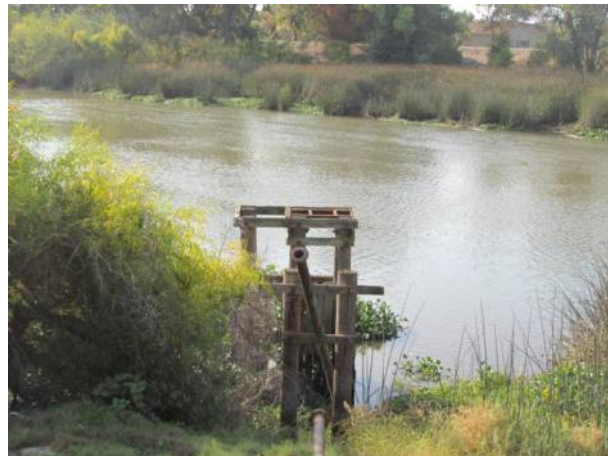
Levee Mile Report Line	20
Start Levee Mile	1.13
End Levee Mile	1.13
Location	Water Side
Category	
Item	Encroachments

Looking southwest at wooden pump stand in channel.

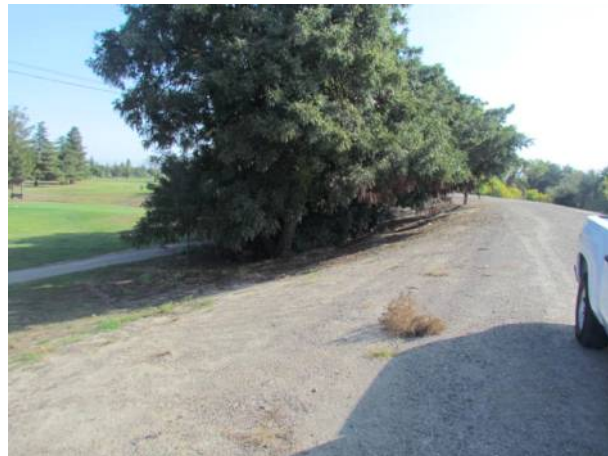
Levee Mile Report Line	22
Start Levee Mile	1.13
End Levee Mile	1.13
Location	Land Side
Category	
Item	Trim / Thin Trees

Looking east at dense vegetation near pump station on landside toe.

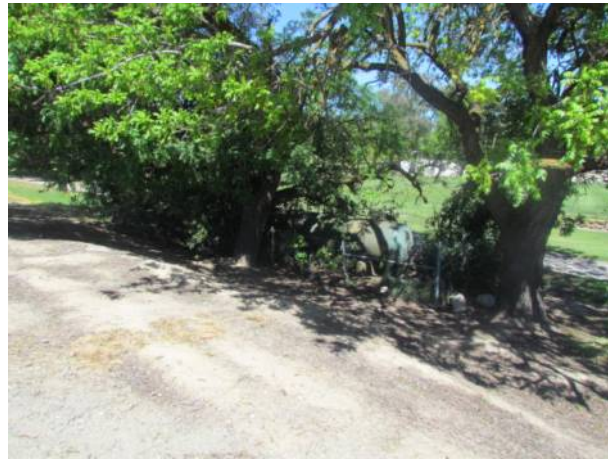
Levee Mile Report Line	22
Start Levee Mile	1.13
End Levee Mile	1.13
Location	Land Side
Category	
Item	Trim / Thin Trees

Looking north at dense vegetation on landward toe around propane tank.

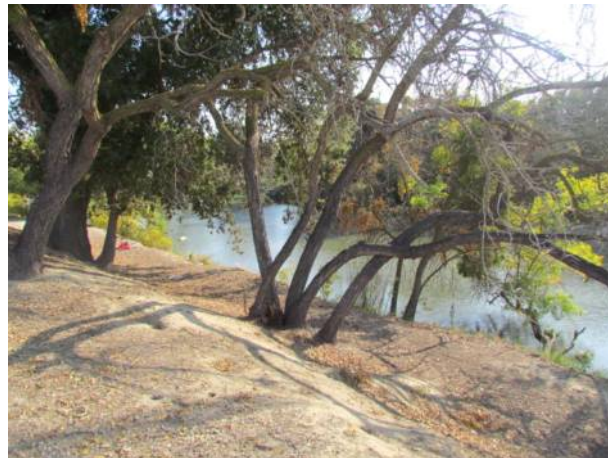
Levee Mile Report Line	25
Start Levee Mile	1.23
End Levee Mile	1.23
Location	Water Side
Category	
Item	Trim / Thin Trees

Looking southwest at several dead trees on waterside slope.

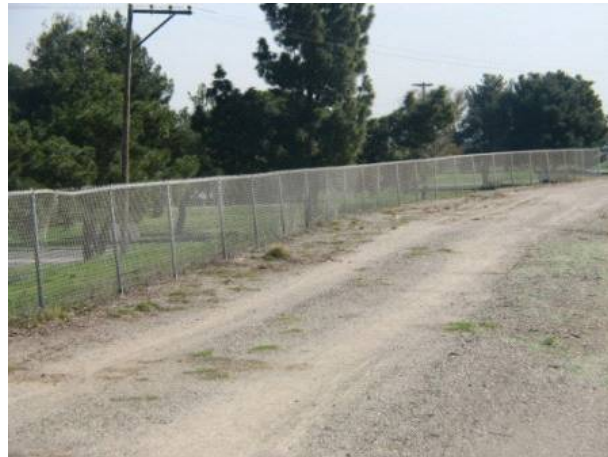
Levee Mile Report Line	29
Start Levee Mile	1.47
End Levee Mile	1.52
Location	Land Side
Category	
Item	Encroachments

Fence at landside shoulder from LM 1.47 to 1.52

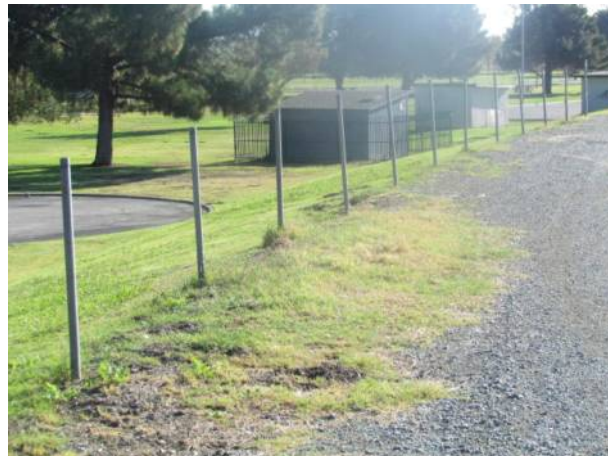
Levee Mile Report Line	29
Start Levee Mile	1.47
End Levee Mile	1.52
Location	Land Side
Category	
Item	Encroachments

Looking northeast at fence poles on landside shoulder.

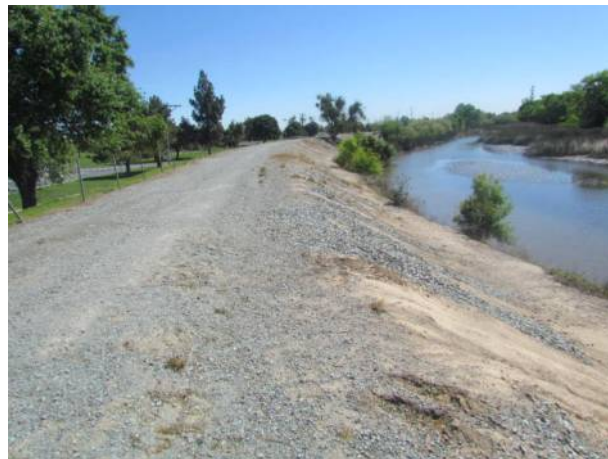
Levee Mile Report Line	30
Start Levee Mile	1.47
End Levee Mile	1.53
Location	Water Side
Category	
Item	Slope Stability

DWR ID: DWR_RD0404_02_s_2012_6									
30	1.47	1.53		Slope Stability	WSA/W Ma	S1 : Repair slope instability. Inspector Comments: There are several foot traffic erosion sites along the waterside slope.	37.918490 ° -121.296650 °	37.918518 ° -121.295690 °	1 Y
DWR ID: DWR_RD0404_02_s_2012_1									
31	1.47	1.47		Erosion / Bank Caving	WS C Ma	E1 : Note and monitor erosion site. Inspector Comments: The hole appears to be a fire pit. District will determine if the hole is a fire pit or sink hole. No visible pipe at this location.	37.918490 ° -121.296655 °	37.918490 ° -121.296655 °	2
DWR ID: DWR_RD0404_02_s_2012_2									
32	1.51	1.51		Animal Control	LS M Ma	A3 : No rodents visible, but rodent burrows visible; need to backfill and compact or grout burrows.	37.918535 ° -121.295980 °	37.918535 ° -121.295980 °	61
DWR ID: DWR_RD0404_02_s_2012_61									
33	1.53	1.53		Slope Stability	WSA/W Ma	S2 : Repair the levee slope damaged by foot traffic and prevent access where possible.	37.918529 ° -121.295684 °	37.918529 ° -121.295684 °	9 Y

Looking southeast at repaired sites on waterward slope.

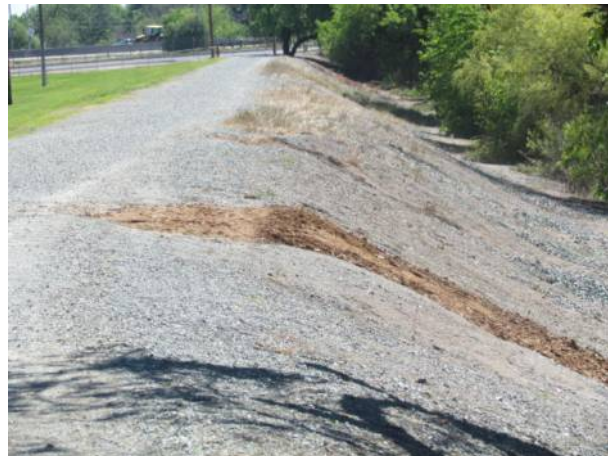
Levee Mile Report Line	33
Start Levee Mile	1.53
End Levee Mile	1.53
Location	Water Side
Category	
Item	Slope Stability

Looking east at repaired site on waterward slope.

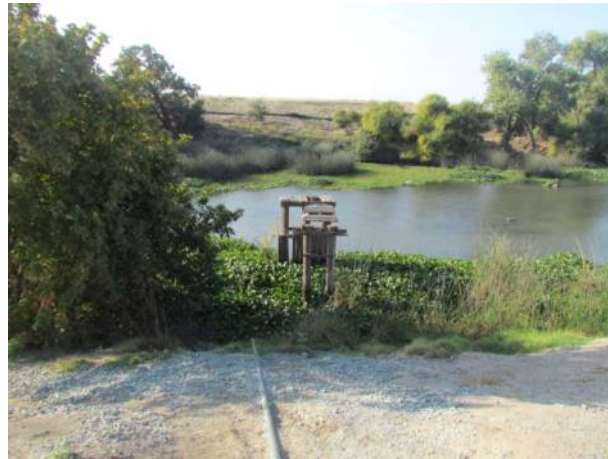
Levee Mile Report Line	34
Start Levee Mile	1.55
End Levee Mile	1.55
Location	Water Side
Category	
Item	Encroachments

DWR ID: DWR_RD0404_02_f_2012_9									
34	1.55	1.55		Encroachments	WS M En	EQ : Equipment Inspector Comments: Abandoned pump stand in channel should be removed and 3" galvanized pipe on waterside slope. Pipe was dug out by unknown person. Left major trench (hole) on waterside slope. Trench (hole) should be replaced before flood season. Three inch pipe has been removed and trench backfilled.	37.918397 ° -121.295110 °	37.918397 ° -121.295110 °	60 Y
DWR ID: DWR_RD0404_02_s_2012_60									
35	1.76	1.76		Trim / Thin Trees	WS M Ma	T1 : Trim trees to at least five feet above ground level.	37.917302 ° -121.291778 °	37.917302 ° -121.291778 °	59 Y
DWR ID: DWR_RD0404_02_s_2012_59

Looking southwest at wooden pump stand in channel.

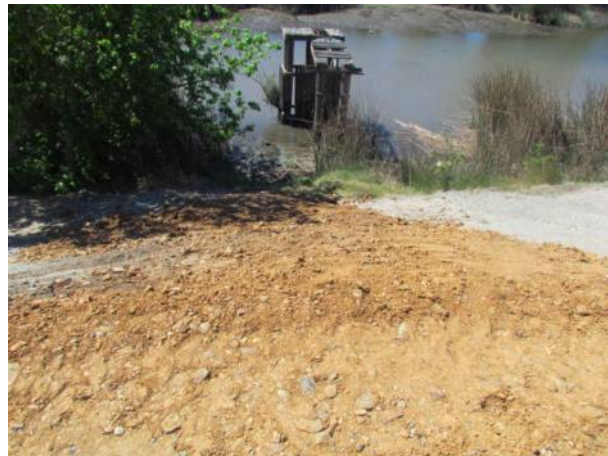
Levee Mile Report Line	34
Start Levee Mile	1.55
End Levee Mile	1.55
Location	Water Side
Category	
Item	Encroachments

Looking south at repaired site on waterward slope.

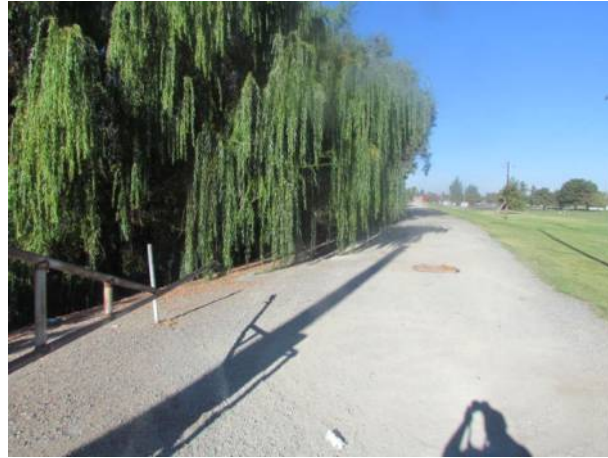
Levee Mile Report Line	35
Start Levee Mile	1.76
End Levee Mile	1.76
Location	Water Side
Category	
Item	Trim / Thin Trees
Looking west at overhanging tree on waterside slope.	
richard_s_20130304_313.JPG
